HARBOUR HOME INSPECTIONS

VISUAL HOME INSPECTION REPORT

DATE: Tuesday, May 12, 2020
INSPECTION REFERENCE: 5427JS
FOR: John Smith
INSPECTION LOCATION: 13 Ocean Parade, Milford
TIME: 9:00 – 10:50am
INSPECTOR / AUTHOR: Mark Hadfield (NZTCC 1991)
WEATHER: Fine and generally dry in the preceding week

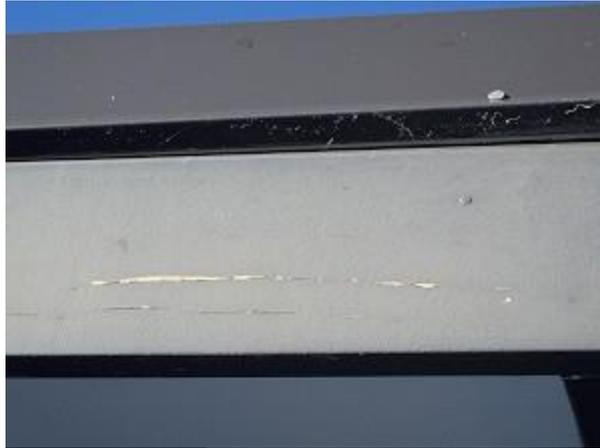
The dwelling is clad and finished with some longer life lower maintenance products (brick cladding, fibrocement cladding, aluminium joinery, colour-bond style steel roof cladding, colour-bond style spouting plus PVC downpipes etc) and some timber products and materials (timber mouldings plus timber eave trims etc) that will require a regular or a somewhat elevated level of maintenance. The finishing quality of the tradesmen appears good and no shortcuts or deliberate poor original finishing was viewed. Largely the dwelling is very well maintained although some fascia and bargeboard timbers have not been repainted for some time, some non-urgent general maintenance is required. No specific maintenance concerns were viewed.

Some minor maintenance required

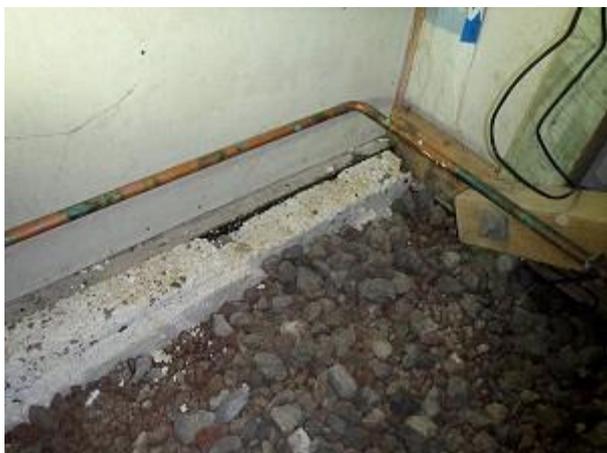
Block foundation waterproofing (Addition)

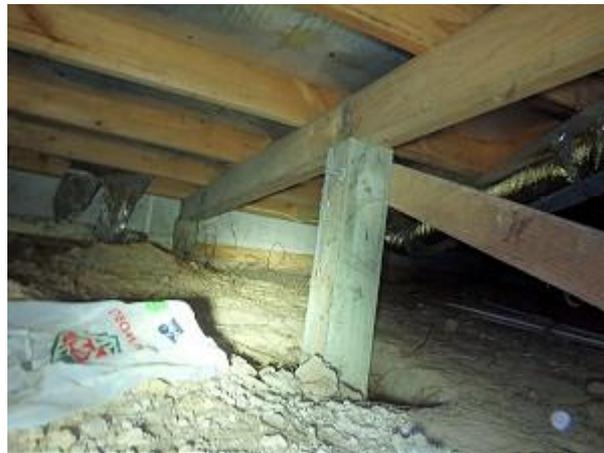
East subfloor

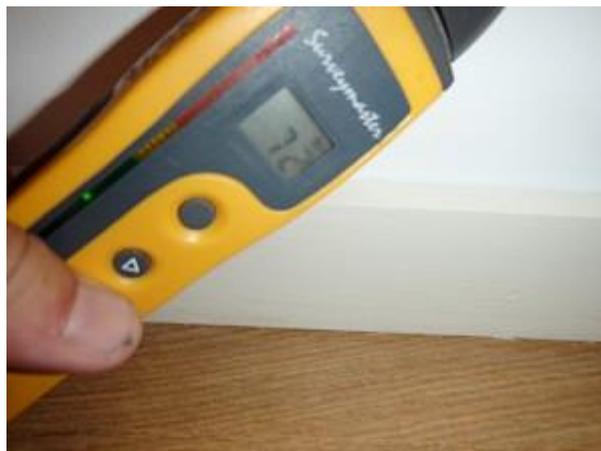
No current high or concerning internal moisture meter indicative RF scan readings were recorded and no signs of damage were seen. The dwelling has no high risk water ingress design details such as direct fixed monolithic cladding, flat or parapet roof sections, or internal decks and includes full eaves. No specific water ingress related concerns were viewed but it is noted that there is some subterranean block retaining and also that the downstairs shower is over a bath. The bath lip configuration is not ideal as it is not behind the wall cladding / waterproofing making the bath to wall junction reliant on sealant rather than the upstand and cladding forming a mechanical seal. This junction will need to be well maintained. No elevated RF readings or damaged was seen in the garage opposing the shower / bath. This area will need to be regularly monitored.

Typical low moisture scan indication reading

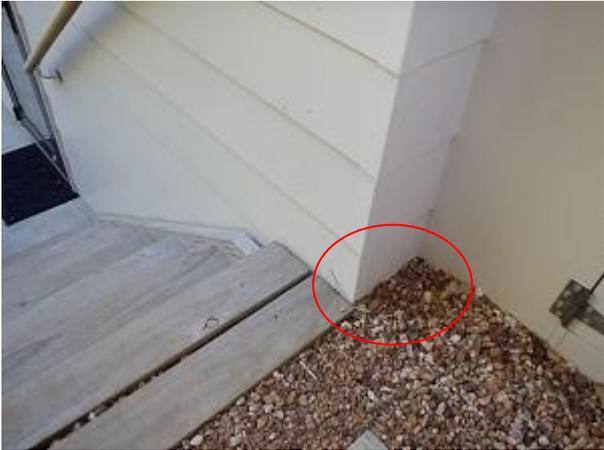
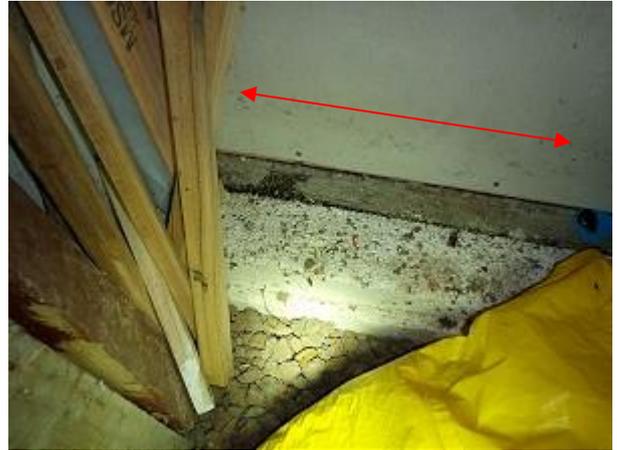
A- To the south east corner of the garage the stone ground cover is filled onto the weatherboards. This is about 150mm deep. This appears above the block retaining wall of the garage. This cladding will not be waterproofed. No damage was seen opposing this but this detail is not ideal. It is advised that the ground levels should be altered (or be suitably packed away & free draining) to ensure the ground cover is not over the blocks and waterproofing. This appears very easy to conduct and is not a significant concern.

Fill on cladding - Approximate fill line

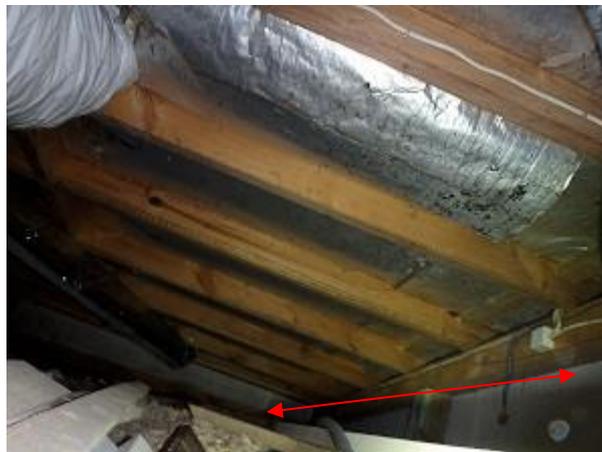
B- The east subfloor area has no real crossflow ventilation. Installing vents (as per the building code requirements) should be conducted to ensure ventilation / drying can occur. This appears very easy to conduct and is not a significant concern.

No real crossflow ventilation

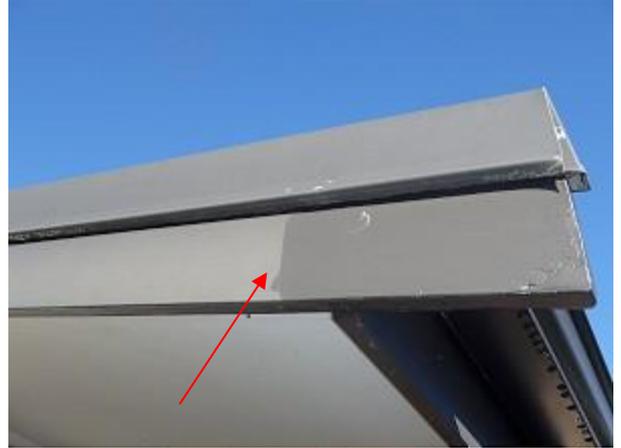
The entire perimeter of the dwelling has eaves to help provide additional protection for the cladding and joinery. Traditional square timber boards are used to form the raking bargeboards and horizontal fascia with the fascia also used to support the spouting. Standard fibrocement sheeting appears used to form the soffit eaves. All appear to be in a good condition although some not so easily seen or reached bargeboards and fascia timbers have not been repainted for some time. No specific roof eave concerns were viewed.

Part repainted bargeboard

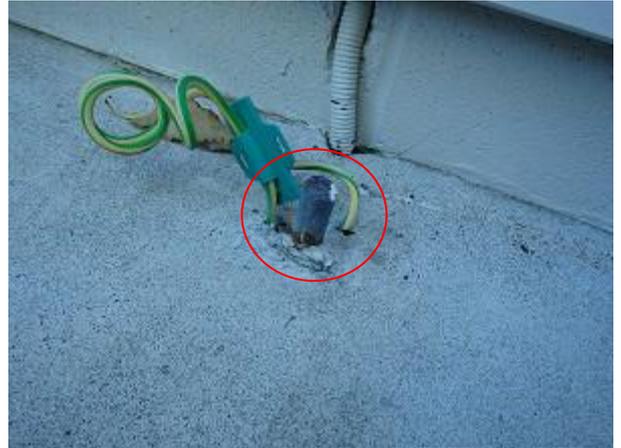
The power is supplied underground. The electrical meter board is located on the external garage wall. The modern updated main fuse board is located in the hall. The fuses used are standard modern miniature circuit breakers. (MCB) As expected all wiring viewed was the modern tough plastic sheath (TPS) variety. Extensive new wiring has been seen throughout the dwelling although the dwelling has not been fully rewired as some original standard 1980's wiring remains. A heat pump ducted air reticulation system is installed. No specific electrical concerns were viewed but the earth wire and the wire connection fitting to the south earth peg is embedded in the concrete path which, over time, may affect the earthing. This will need to be monitored and in time may need to be modified.

Embedded earth wire

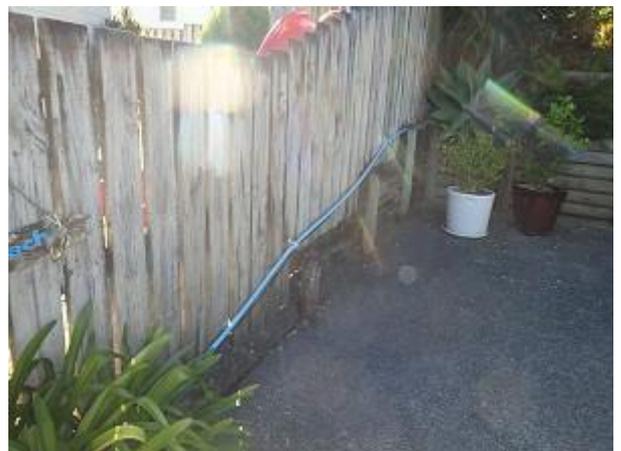
An electric 180 litre Rheem mains pressure hot water cylinder (HWC) manufactured in 2010 is located in the subfloor. (180 litre mains pressure is the recommended family system) The shower pressures are good even with another hot tap running. The dwelling is fitted with standard polybutylene style grey and black plastic water pipes where viewed. The waste pipes are PVC. The blue plastic main water pipe is fixed to the north fence which is functional but is not overly aesthetically pleasing. No specific plumbing concerns were viewed.

Water pipe on fence

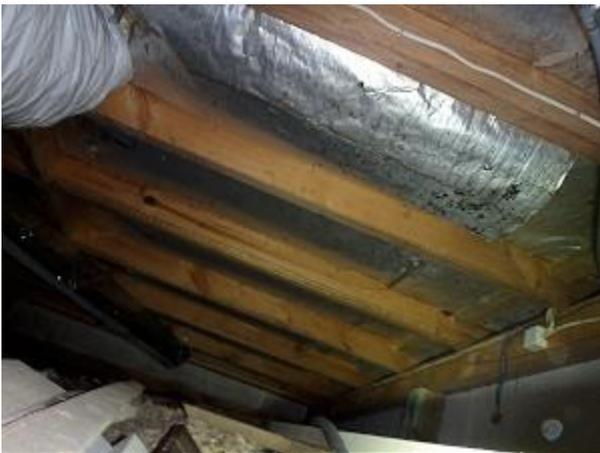
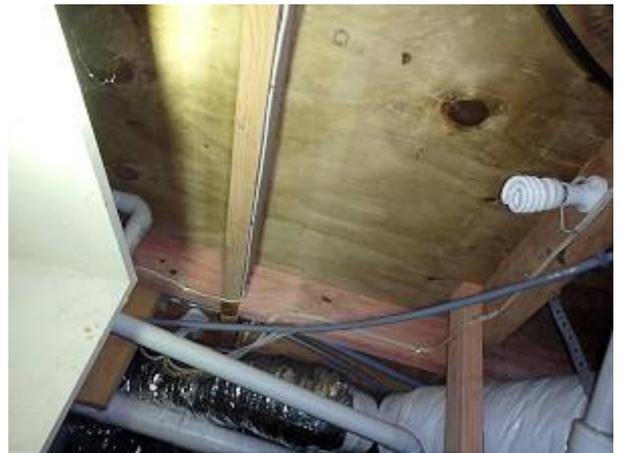
The dwelling (excluding the garage) is required to be insulated. (Post 1978 regulations) East subfloor insulation is installed but the area insulation under the shower (newer floor) has not been reinstated and this should be conducted. (Minor) One small wall area was viewed (west end of the dwelling in the roof cavity of the garage to the end wall of upstairs) and this was insulated with blown fibre (Rockwool) style insulation. This would have been against the external building paper but now that it is exposed, (in the cavity) after the addition there is a potential it could fall out. This will at least be needed to be monitored but ideally this should be better secured with a layer of building paper. The garage ceiling has batts style insulation although not required, and also double glazing. The main upper ceiling was originally insulated with fibre fill but there is now a thick batts layer with several additional bundles of batts just sitting up there to be used if desired. In addition, the windows are double glazed as per modern requirements. No specific insulation concerns were viewed.

East subfloor Sisalation insulation foil / Area of missing foil

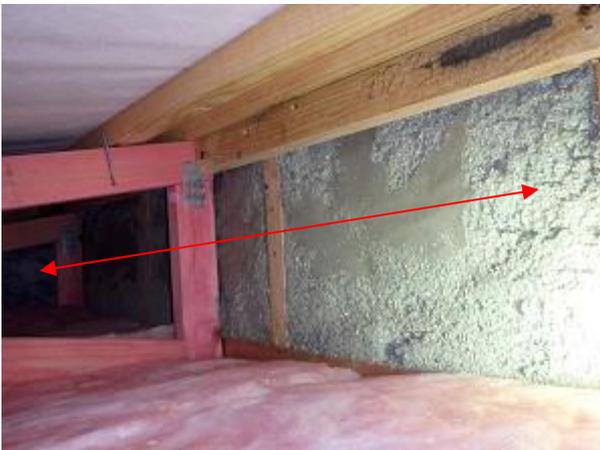
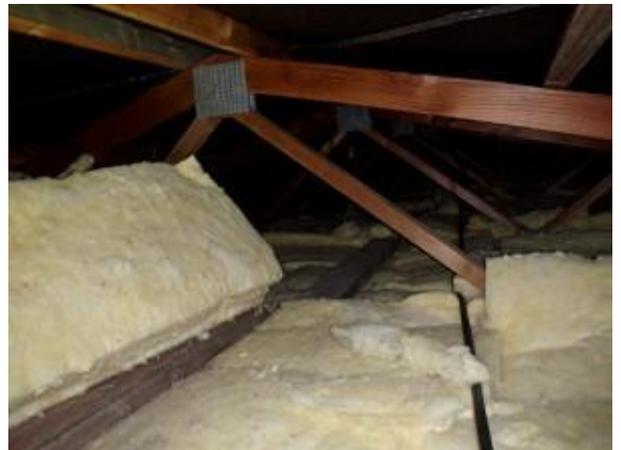
Wall batts not supported (& garage ceiling batts) Ceiling insulation batts (& additional batts)
