HARBOUR HOME INSPECTIONS

VISUAL HOME INSPECTION REPORT

DATE: Tuesday, May 12, 2020
INSPECTION REFERENCE: 5427JS
FOR: John Smith
INSPECTION LOCATION: 13 Ocean Parade, Milford
TIME: 9:00 – 10:50am
INSPECTOR / AUTHOR: Mark Hadfield (NZTCC 1991)
WEATHER: Fine and generally dry in the preceding week

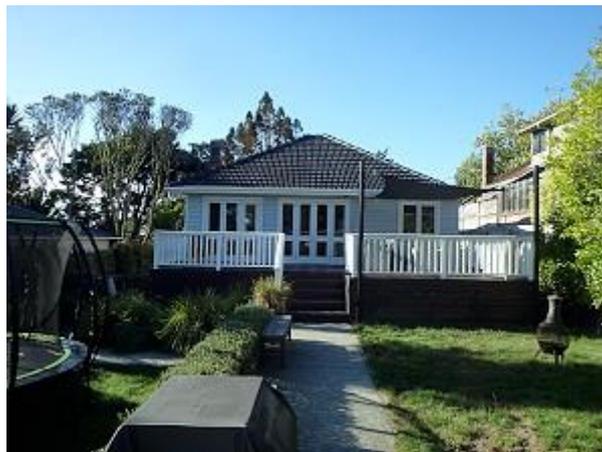
Northerly elevation (Nominal)

I have called the front door face north for reference purposes only

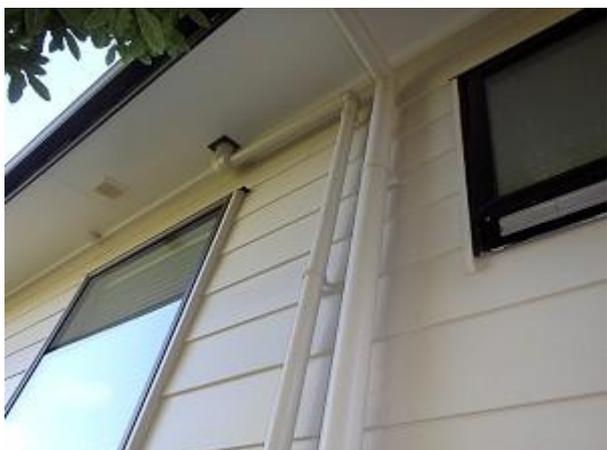
Weatherboard overview

The dwellings main cladding is longer life lower maintenance fibrocement weatherboard planks, likely the Hardiplank type. The weatherboards themselves appear in a good condition. The horizontal weatherboard system has no specific historical concerns and has been installed in this manner for many years. It can be seen that the lower (newer) weatherboards are on a cavity system as now required. The new and original weatherboards have been very well matched. The base cladding is fibrocement sheeting which also appears in a good condition. This is actually used near the front door (east side & above the lower block retaining – to the old subfloor area) but this is not a significant concern. (But also view the Foundations & Framing section) The dwellings minor cladding is a non-load bearing vented brick cavity veneer system. The bricks have been rendered over but the top air and bottom egress vent were able to be viewed. The brick system includes a standard ventilation cavity between the brick veneer and structural timber framing to expel any minor water ingress to open weep holes at the base of the bricks. (The egress vents seen) This brick cavity system has no specific historical concerns and has been installed in this manner for many years. No specific cladding concerns were viewed although to the west upper end of the dwelling the weatherboards would benefit from a good clean and are ready to be repainted. Overall the flashings were considerably better than seen on most dwellings including their use to the side of the meter board, on the roof and at bargeboard ends etc.

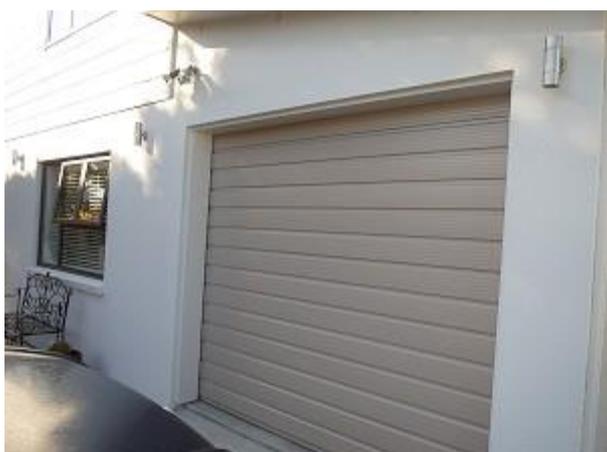
Brick overview & typical egress vent

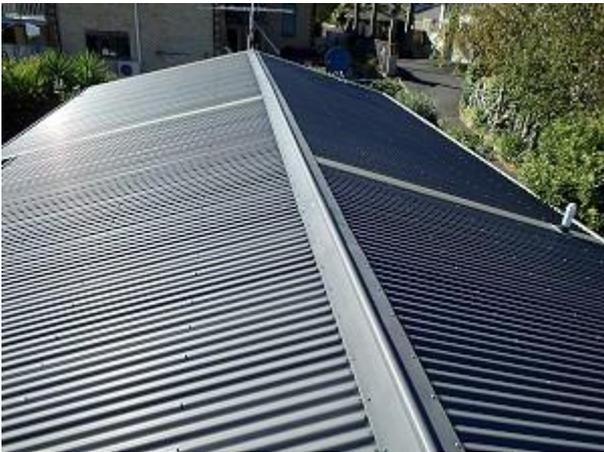
Roof design overview & cladding

The main gable and lower garage skillion roofs are constructed with prefabricated trusses. (Preformed engineered triangle structures constructed normally to span outside wall to outside wall) The roof structure appears standard, no defects were seen. Due to the low pitch of both roofs these were only able to be partly crawled through but no defects or high risk factors were seen. The trusses are clad with building paper and standard colour-bond style steel corrugated iron sheets. The corrugated iron sheets appear to be in a good condition. The roof cladding flashings (two on the upper roof) were better formed than usually seen. No specific roof concerns were viewed.

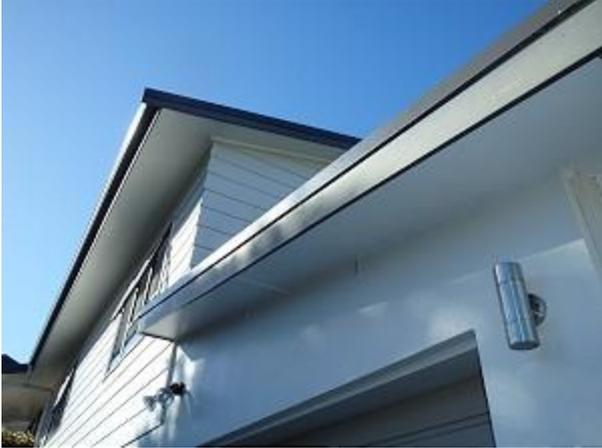
Full eaves overview

The entire perimeter of the dwelling has eaves to help provide additional protection for the cladding and joinery. Traditional square timber boards are used to form the raking bargeboards and horizontal fascia with the fascia also used to support the spouting. Standard fibrocement sheeting appears used to form the soffit eaves. All appear to be in a good condition although some not so easily seen or reached bargeboards and fascia timbers have not been repainted for some time. No specific roof eave concerns were viewed.

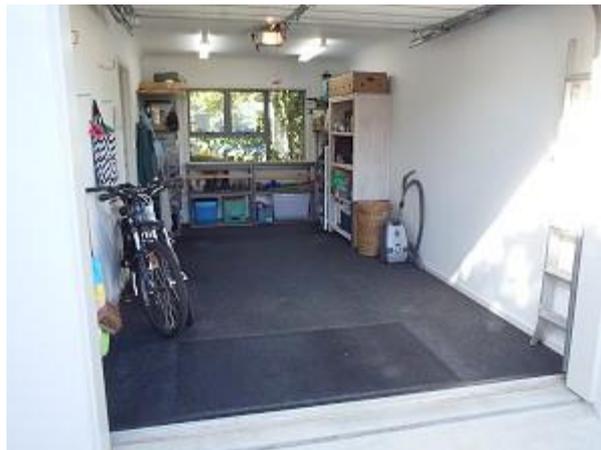
Garage overview

The internal access one car garage is fully integrated into the (newer) construction of the dwelling. The colour-bond steel door is powered. No specific garage concerns were viewed.

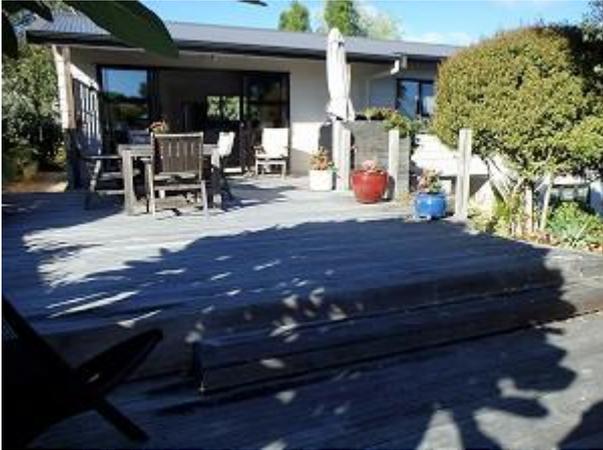
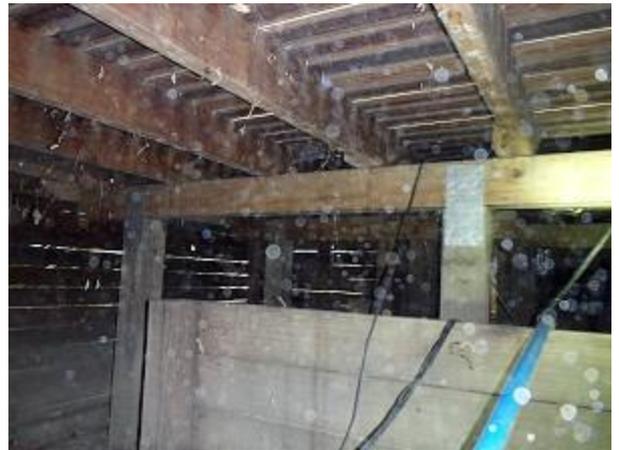
North east deck overview & substrata

The low hardwood clad north east deck appears well finished and feels solid. The substrata was typical Senton pile braced construction. No specific deck concerns were viewed.

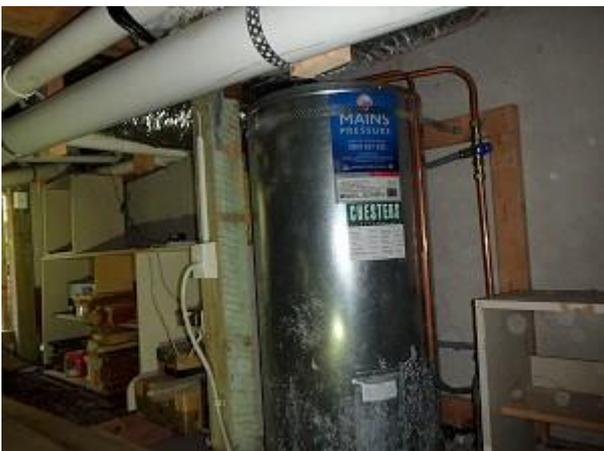
Standard HWC

An electric 180 litre Rheem mains pressure hot water cylinder (HWC) manufactured in 2010 is located in the subfloor. (180 litre mains pressure is the recommended family system) The shower pressures are good even with another hot tap running. The dwelling is fitted with standard polybutylene style grey and black plastic water pipes where viewed. The waste pipes are PVC. The blue plastic main water pipe is fixed to the north fence which is functional but is not overly aesthetically pleasing. No specific plumbing concerns were viewed.
